DOWNTOWN ORANGEVILLE HERITAGE CONSERVATION DISTRICT STUDY

*PREPARED BY:
TOWN OF ORANGEVILLE PLANNING DEPARTMENT
HERITAGE ORANGEVILLE*

MARCH, 2002

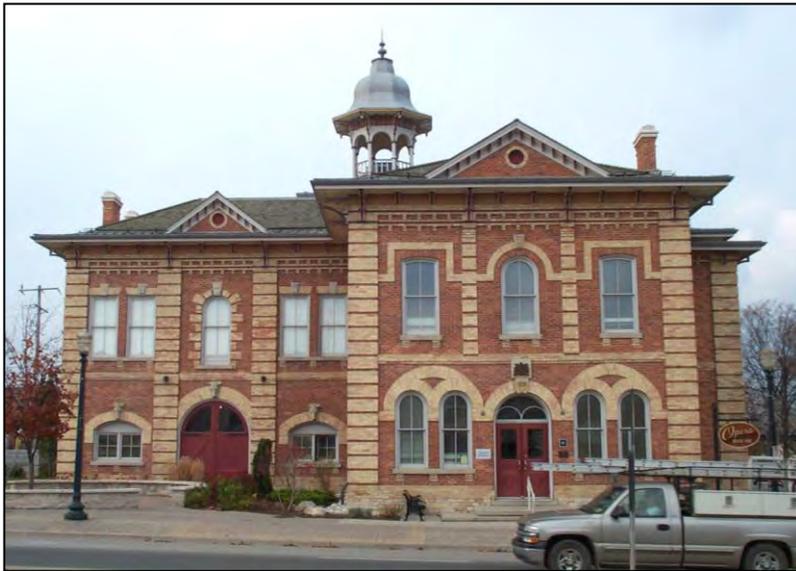
The most common architectural style in the study area is Italianate. This style of architecture began in England in the early 1800s as a revival of the dignified architectural forms of the Italian Renaissance and specifically of the Italian country villas of that period. Typical features of the style include the prolific use of brackets under the eaves, low-pitched hip-roofs, contrasting materials, repetition of decoration, brick quoining and round-headed windows. An excellent example of the Italianate style is the Town Hall at 87 Broadway.

Town Hall, 87 Broadway, an example of the Italianate style

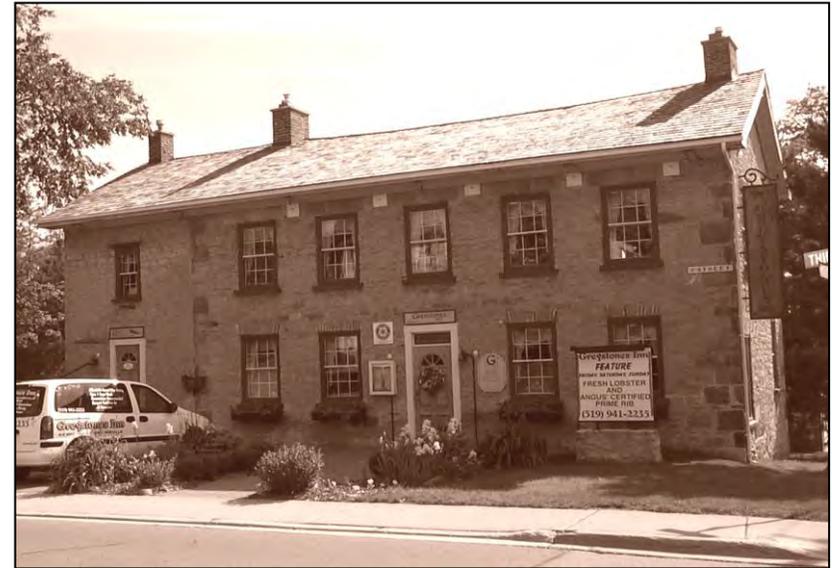
rectangular openings with centre doors. The roofs tend to be medium-pitched. The simplicity of design lent itself to a popular design for worker's cottages. This style was used in the construction of the building at 63 Broadway.

Greystones Inn, 63 Broadway, an example of the Georgian style

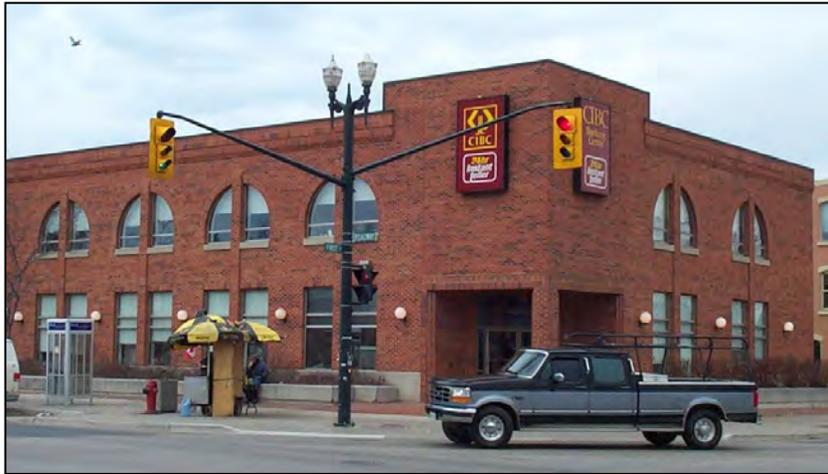
The Gothic Revival style began in England in 1749 when Sir Horace Walpole began to remodel his country house in the medieval style. Over the next 150 years the style became very popular and the most widely recognised style of the Victorian era. Typical features of the style include steeply pitched roofs, pointed arched windows, decorative siding and brickwork, barge boards and finials. In Ontario, this style was commonly used in churches and centre-gable farmhouses. This style was used in the former Canada Post building at 216 Broadway, since demolished, and impressions of this style can be seen in the CIBC building at 2 First Street.

CIBC, 2 First Street, modern impressions of the Gothic Revival style

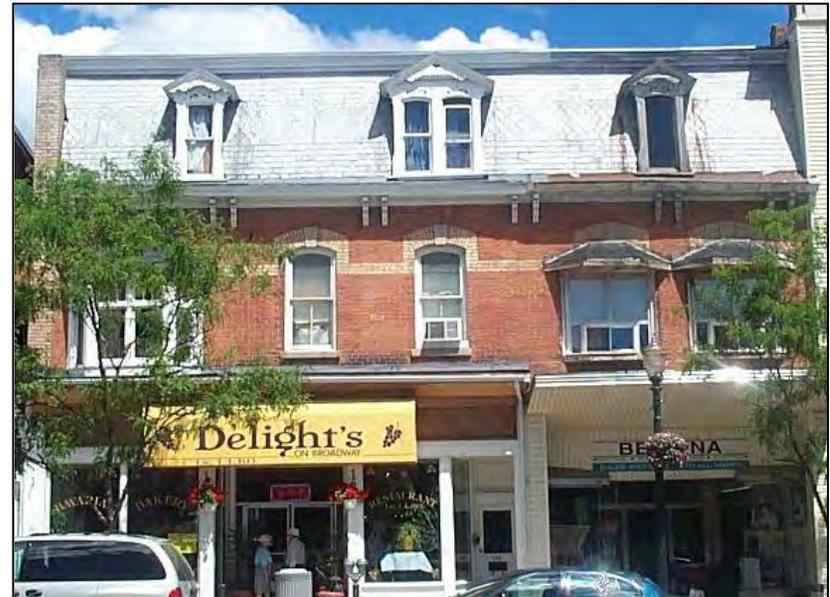
The Second Empire style derives from the official style in France and its colonies during the reign of Napoleon III. The most prominent feature of this style is the mansard roof, developed by 19th century French architect François Mansard. Other features include, a frequent use of bay windows, iron cresting and round-headed windows. Decorative elements also used in Second Empire buildings include bell cast verandas, brackets and the repetition of ornate details. This style was particularly popular for use in hotels of the period because it permitted the use of a full upper storey of attic space. An example of this style is the two-and-a-half storey building at 135-139 Broadway.

135-139 Broadway, an example of the Second Empire style

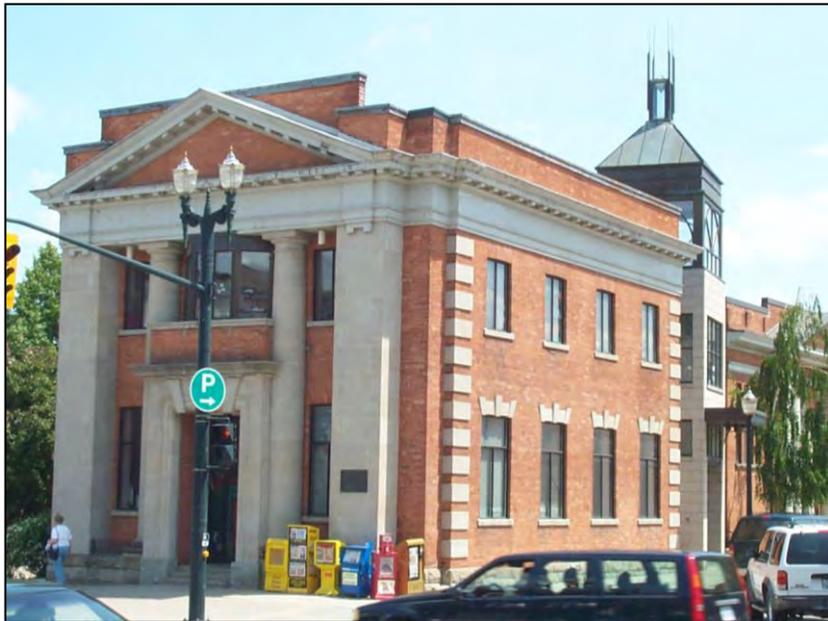
The Edwardian Classicism style developed as a reaction to the increasingly complex architectural styles of the late Victorian era and became prevalent in the early 1900s. The simple but formal composition of the Classicism building included balanced façades, simplified gable and pyramidal roofs, large dormers, classical ornamentation and heavy-columned verandas with classical columns and brick piers. An excellent example of the style is the former Royal Bank building (currently the library) at 144 Broadway.

Former Royal Bank building, 144 Broadway, an example of Beaux-Arts Classicism

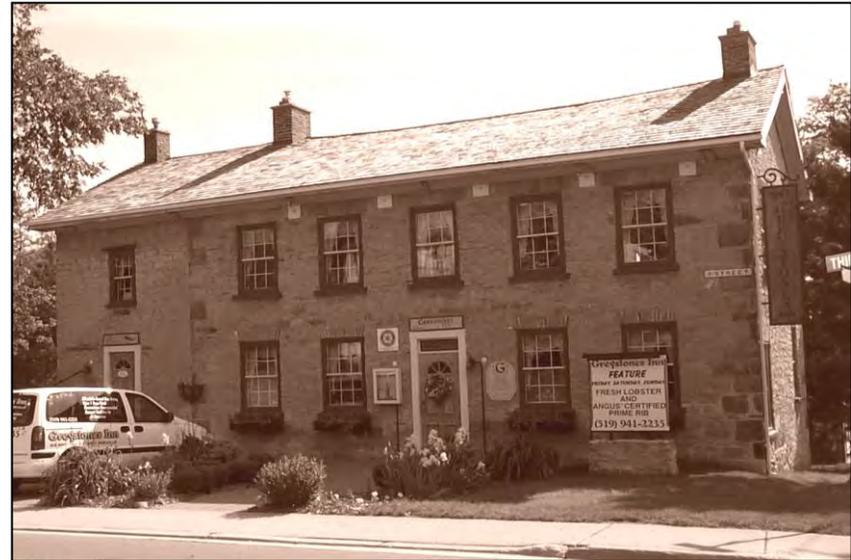
63 Broadway, Greystones Inn

The entire exterior is in excellent restored condition. This building is a true landmark and a tribute to the built heritage of the town.

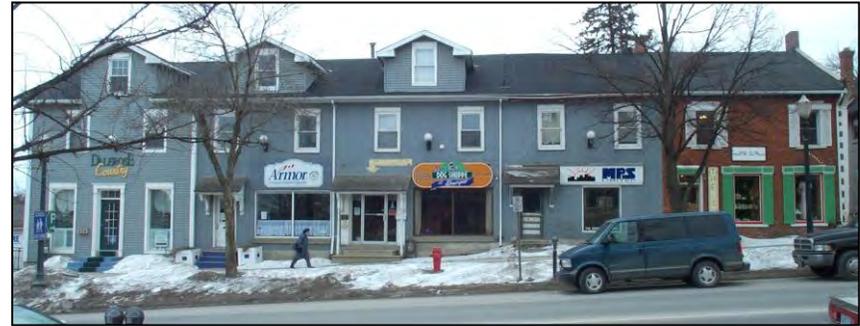
64-72 Broadway

The second storey of each unit has two symmetrically placed windows that were all originally one-over-one sashes as in 72 Broadway. The replacement windows in 64, 66, 68 and 70 are larger than the original window openings and thus the original voussoirs and sills have been eliminated. Most of the main floor display windows are the result of enlargement or relocation of the original openings. The doorways are also altered in dimension and in the former window openings. The shed roof canopies over the doors of 66, 68, and 70 and the portico over 64 are not original and are unsympathetic to the simple lines of the Georgian style.

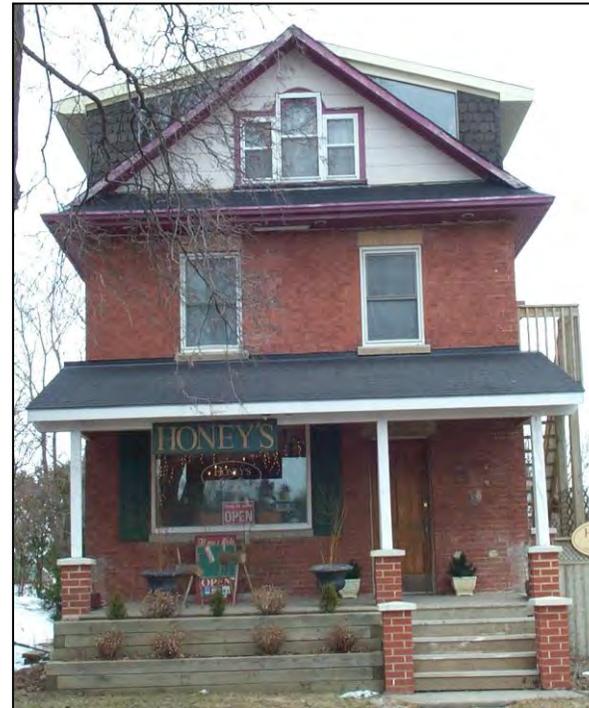
65 Broadway, Honey's Café

The windows have rectangular openings and are regularly spaced with one-over-one sash arrangements. The window in the third floor gable was a Palladian style, the center window being arched-topped and flanked by two shorter windows. Evidence of the original opening remains but the windows have been replaced with newer windows that are all rectangular. The large plate glass window on the ground floor is not original.

The building has been altered with large dormers on the third level, a wooden staircase/fire exit on the east wall, replacement windows, inappropriate shutters flanking the plate glass front window, and a rebuilt porch supported by new brick piers.

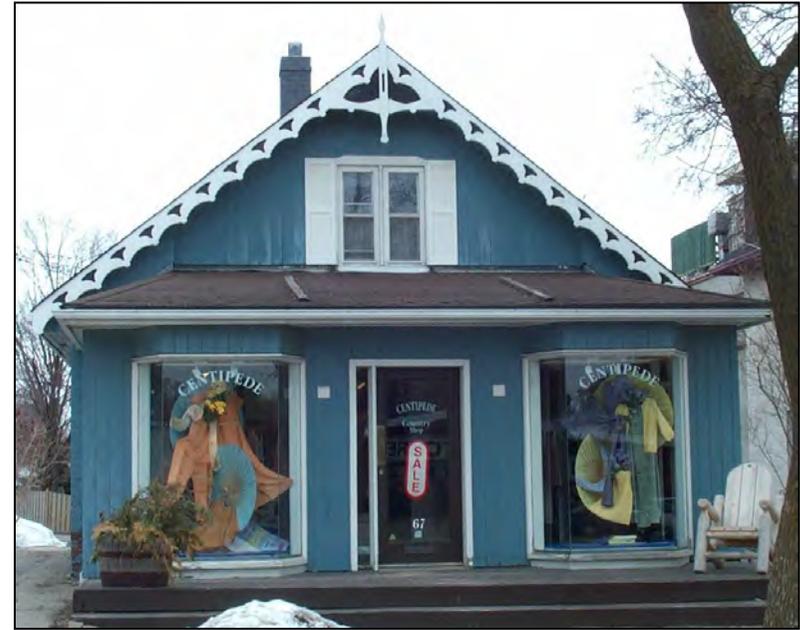
67 Broadway, Centipede
Category A ★★

Date of construction: 1918
Architectural style: N/A
Original owner: George Ellison
Original use: Private residence
Present use: Commercial

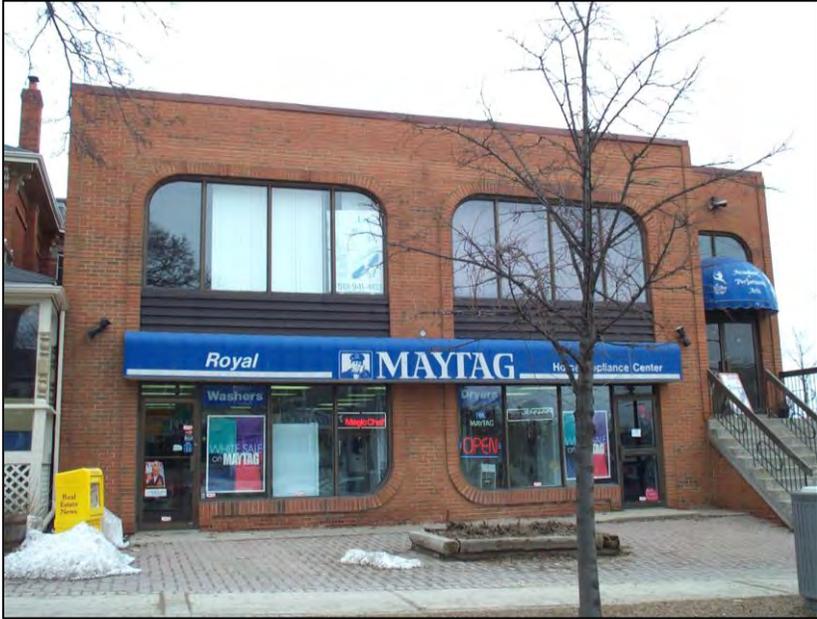
71 Broadway

A building of recent vintage that has little in common with historical or architectural elements found elsewhere in the district. Any building alterations or future development on this site must be complementary and sympathetic to adjacent properties and must not further aggravate apparent disparities.

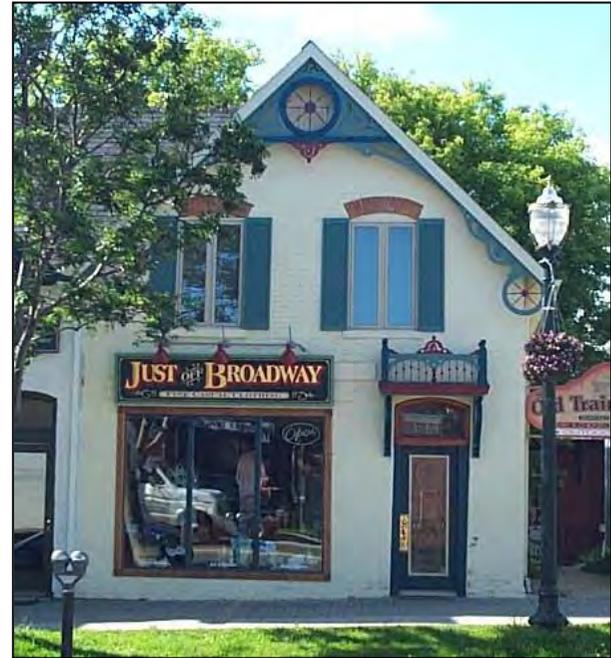
78 Broadway

The two upper floor arched window openings are intact and are headed by brick soldiering and have wood sills. They have been filled with unsympathetic modern sashes and flanked by shutters. On the first story, the segmental door opening is intact and the transom window over the door remains, the sash has been replaced with a new stained glass window. The door itself is not original and the door opening has been boxed in to fit the new door. A new decorative bracketed railing tops the doorway opening. The display window on the main floor has been enlarged from the original. Evidence of the original brick soldiering at 74 Broadway, the east end of the building indicates, that there

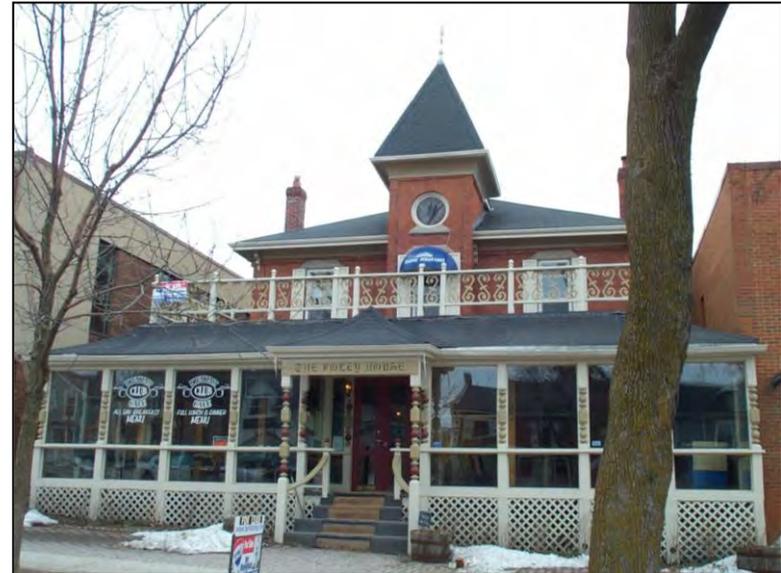
75 Broadway, Foley House

The building is clad in red brick with stone details; window voussoirs and sills. The window sashes appear to be replacements. The present enclosed porch is an expanded alteration of the original. To accommodate commercial businesses, the main floor openings have been opened up within the enclosed porch. The shutters are not original and are not appropriate to this style of building.

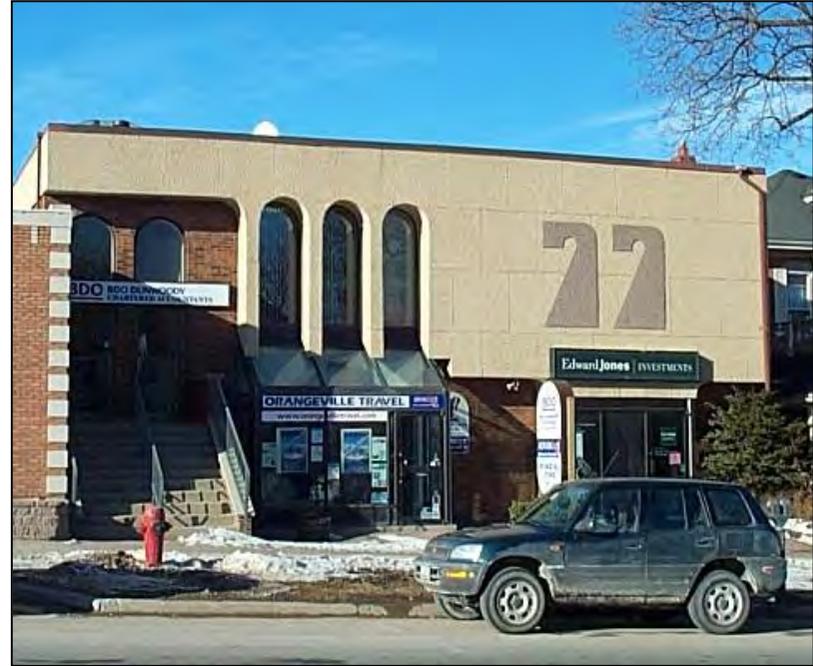
77 Broadway

A Category C building of recent vintage that has little in common with historical or architectural elements found elsewhere in the district. Any building alterations or future development on this site must be complementary and sympathetic to adjacent properties and must not further aggravate apparent disparities in the historical fabric of the district.

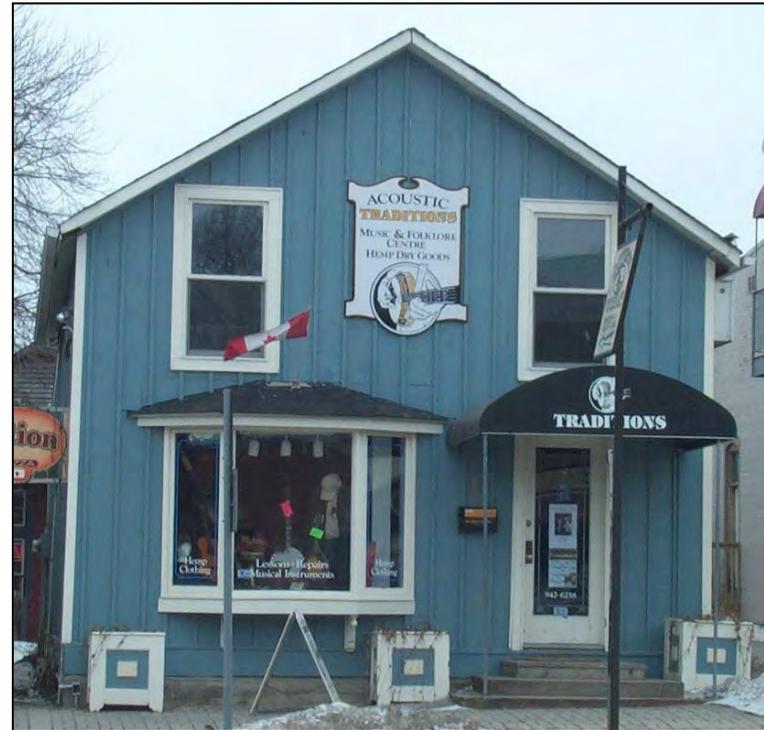
80 Broadway

This building is an example of the vernacular cottage style seen throughout the town. It features a storey-and-a-half shape with a gable roof. The structure is clad in board and batten which is not the original material. The upper storey windows and the first storey door are likely in their original openings, but the main floor three-pane bow window is probably an enlargement of the original. The window sashes and door are more recent replacements. The awning over the door is a modern addition.

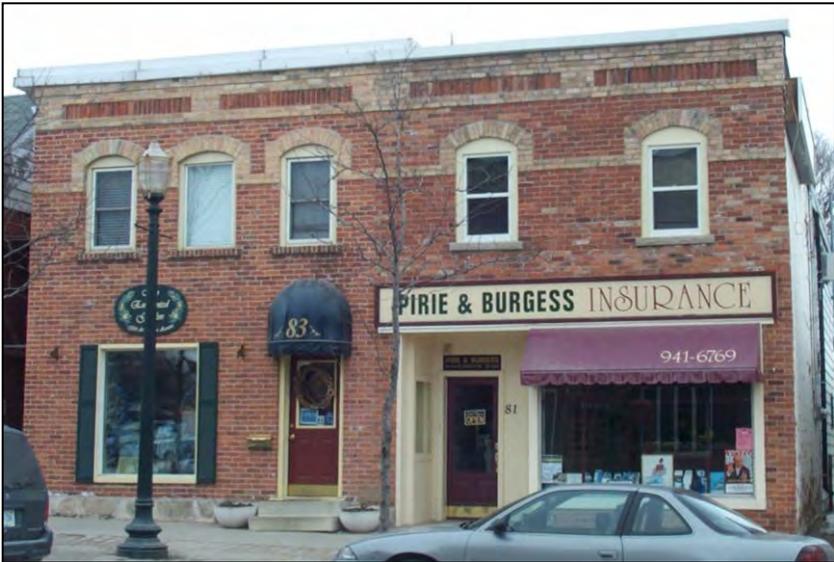
81-83 Broadway

The windows in the second storey are regularly spaced in each unit with three in unit 83 and two in unit 81. The original arched window openings are unaltered but the original sashes have been replaced with undersized one-over-one sashes.

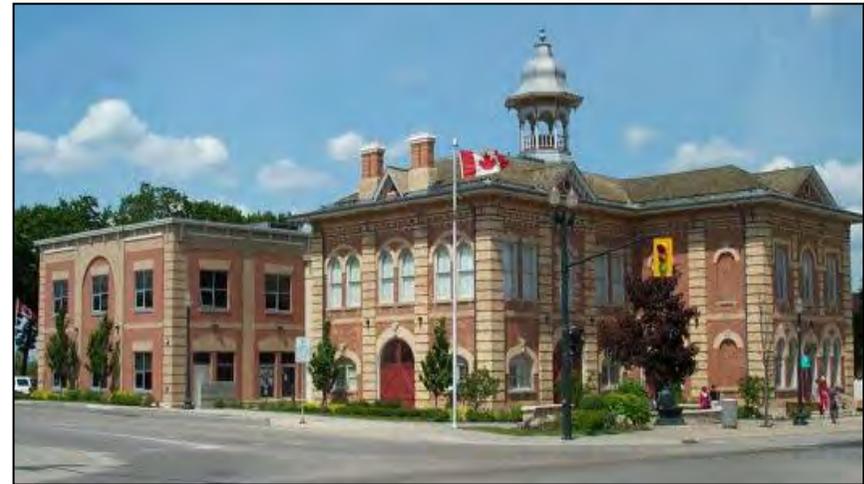
87 Broadway, Town Hall

87 Broadway*, Town Hall
Category A ☆☆☆

Date of construction: 1875
Architectural style: Italianate
Original owner: Town of Orangeville
Original use: Town hall
Present use: Town hall

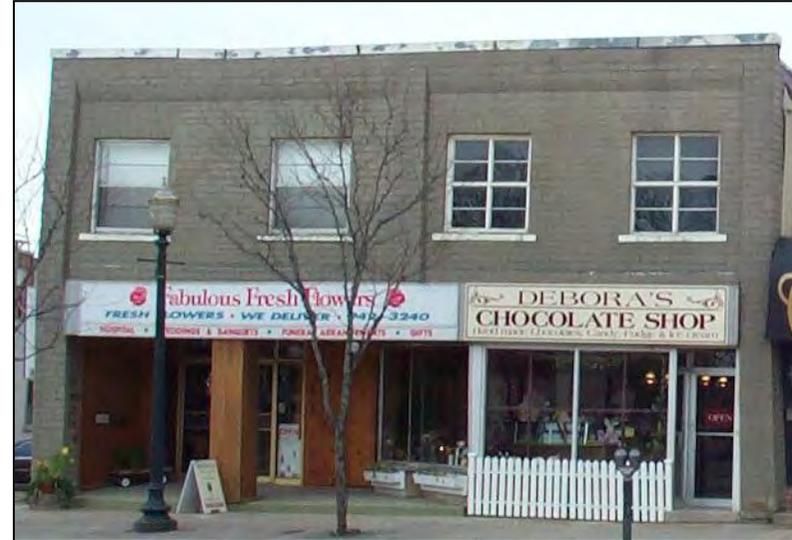
90 Broadway
Category C ⬠

Date of construction: 1890
Architectural style: Italianate
Original owner: N/A
Original use: N/A
Present use: Commercial

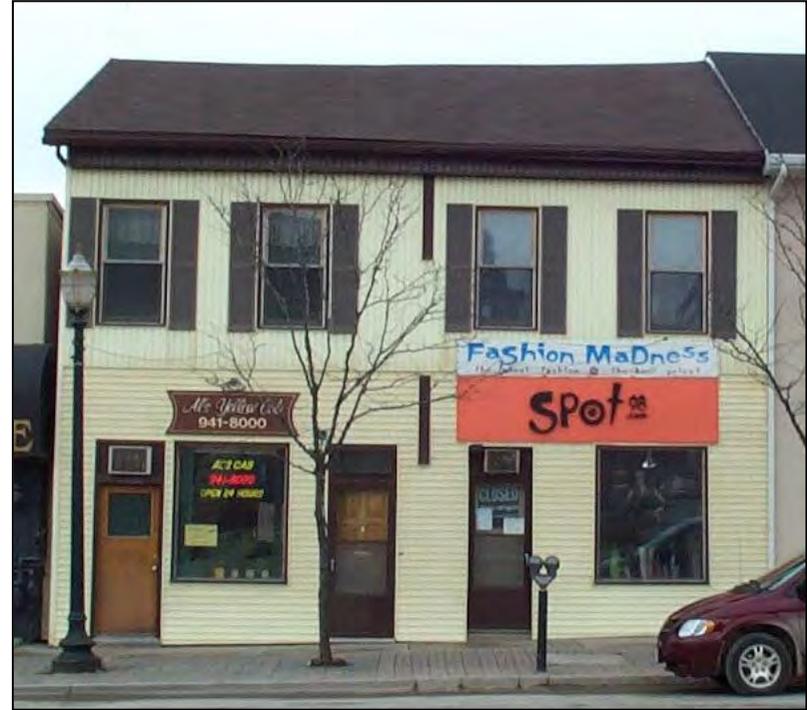
96-98 Broadway
Category C ⚡

Date of construction:	1880
Architectural style:	Georgian
Original owner:	N/A
Original use:	N/A
Present use:	Commercial

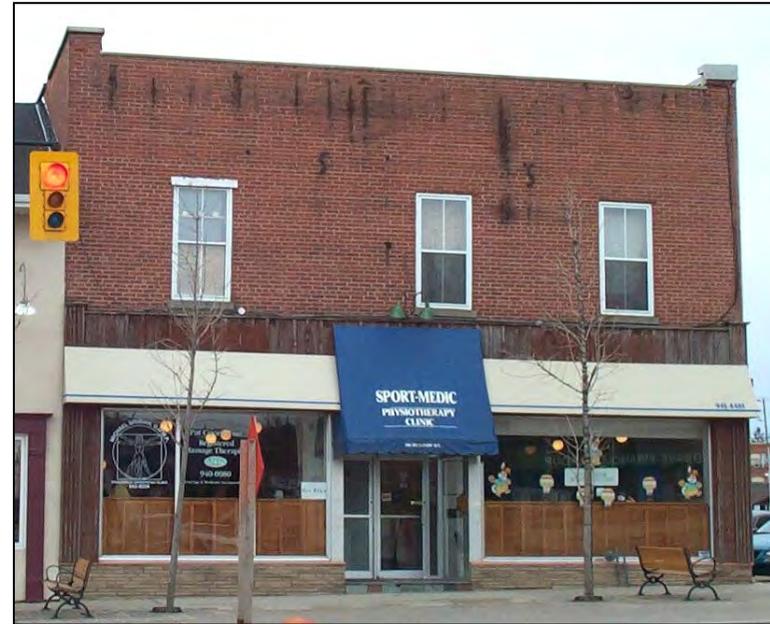
102-108 Broadway

The building may have been constructed as a Georgian style building which subsequently had its roof raised to resemble a simplified Italianate shape. The upper storey is clad in red brick and exhibits none of the decorative elements common to the Italianate style of architecture.

The three second-storey window openings appear to be original, and all have the original stone sills. Only the easternmost window retains its stone cornice. The sashes appear to have been replaced with two-over-two double-hung windows.

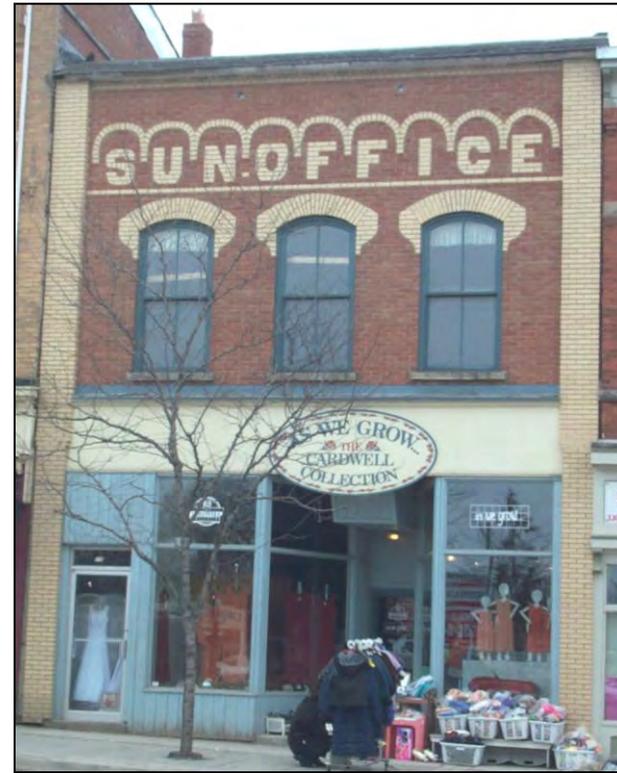
113-115 Broadway

This two-storey building is in the Italianate style. The upper facade is a close reproduction using new materials of the original facade which was taken down in the 1990s. It is clad in red brick with yellow brick detailing. The window openings have limestone sills and are topped by yellow brick voussoirs. The building is flanked by yellow brick pilasters which run from the ground level to the roof line. The roof has a simple raised red brick cornice.

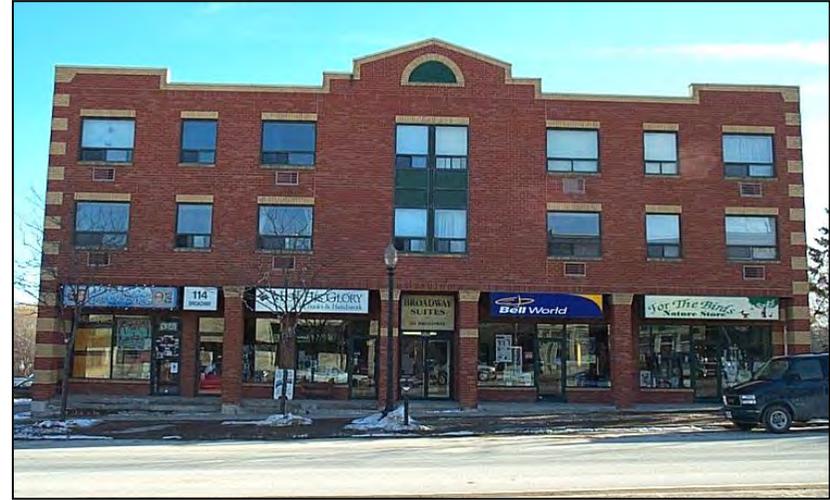
114 Broadway
Category B ☆☆☆

Date of construction: 1990
Architectural style: Modern
Original owner: N/A
Original use: Commercial/ Residential
Present use: Commercial/ Residential

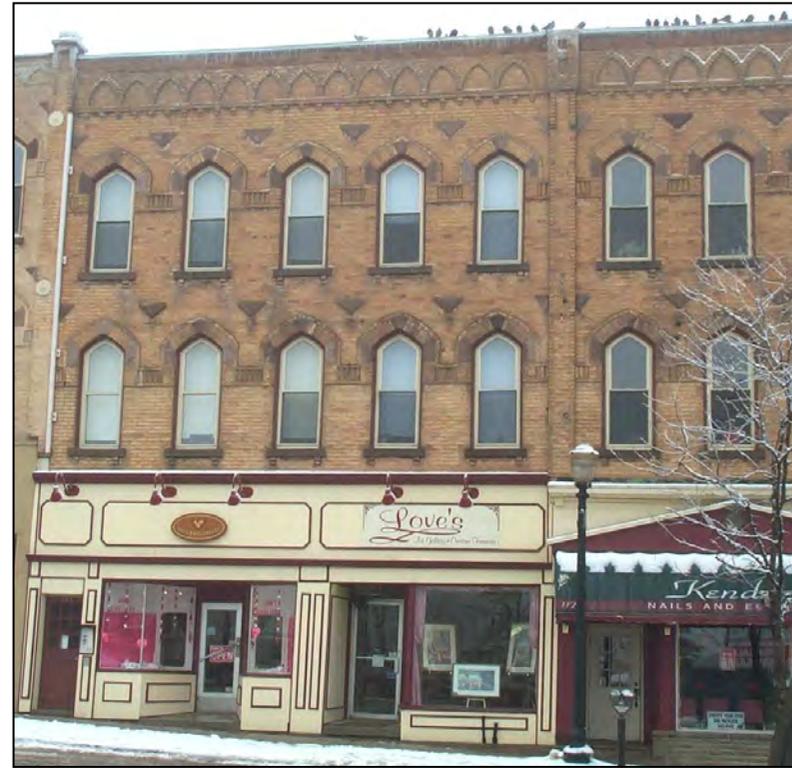
117-123 Broadway

This block is of Italianate design and is characterized by a buff brick field and detailing.

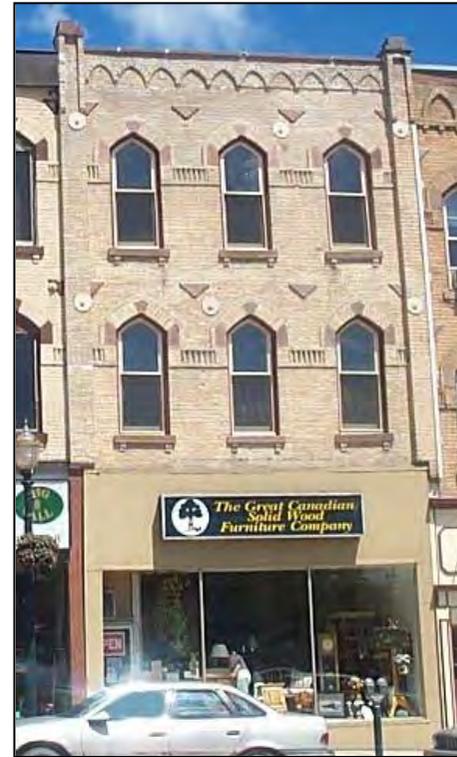
125 Broadway

Added to the McKim Block, this building is of Italianate design and is characterized by a buff brick field and buff brick detailing. The upper floors have five-course banding in buff brick on both stories from window to window on level with the bottom of the voussoirs. The arched voussoirs are pedimented and soldiered in buff brick with a raised buff brick edge.

The pilasters on the upper floors are buff brick and are adorned with medallions.

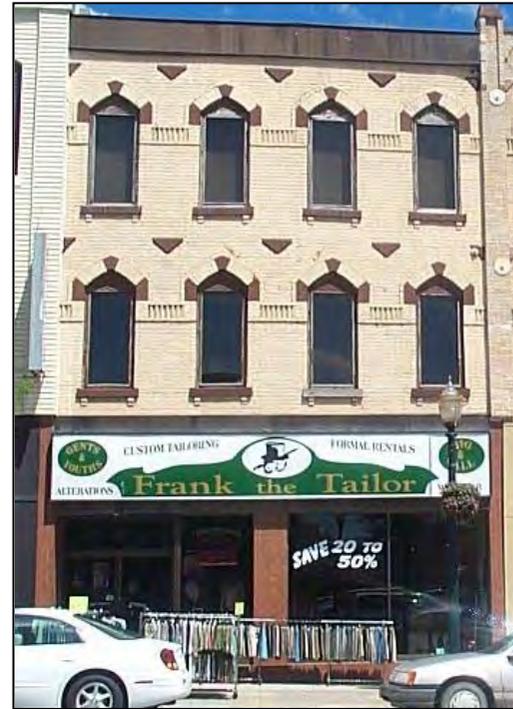
127 Broadway
Category B 🌟🌟

Date of construction: 1882
Architectural style: Italianate
Original owner: James S. Fead
Original use: Commercial/Residential
Present use: Commercial/Residential

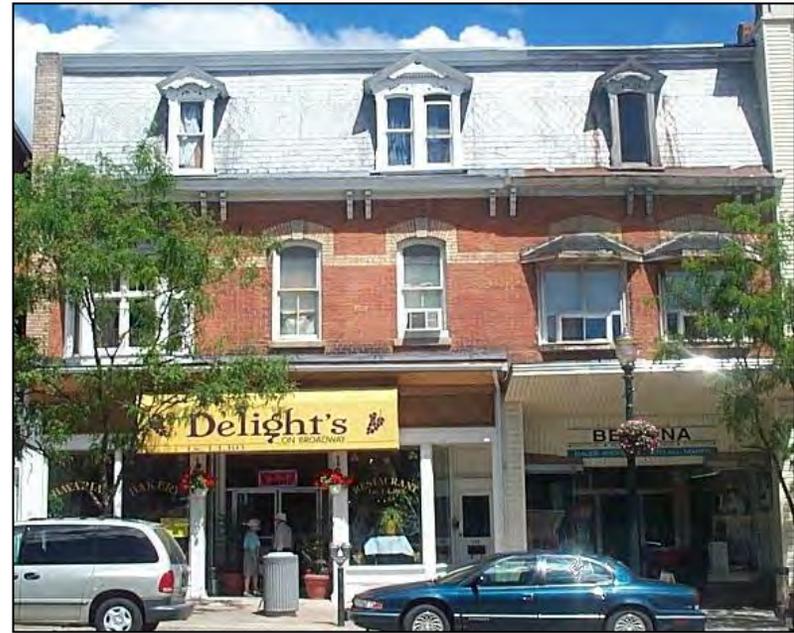
133-139 Broadway

This building is constructed in the Second Empire style whose most prominent feature is a mansard roof with dormers. The middle facade is clad in red brick with buff brick banding running from window to window level with the bottom of the voussoirs which are also of buff brick with keystones. The roof is supported by paired roof brackets.

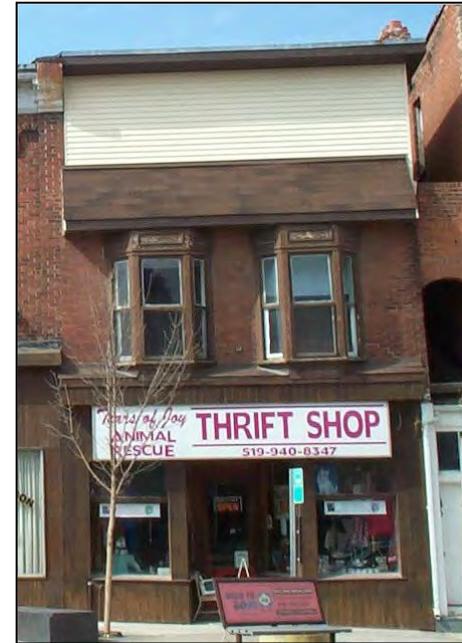
143 Broadway
Category C 🗺

Date of construction:	1886
Architectural style:	Indeterminate
Original owner:	N/A
Original use:	Commercial
Present use:	Commercial

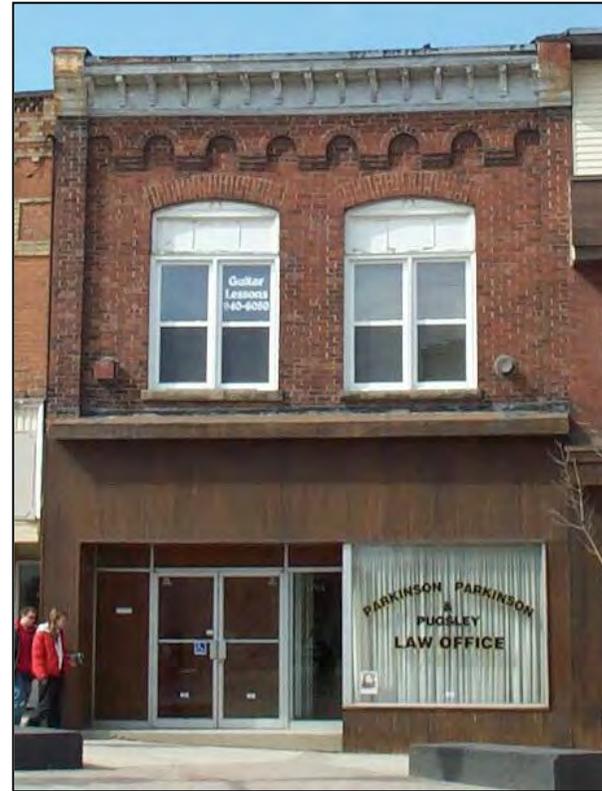
145-147 Broadway

Both buildings are clad in red brick. All the original window openings remain but have been filled with non-operable replacement sashes.

The voussoirs are soldiered in red brick flush with the building. There are no keystones. The pilasters on the upper floor are red brick and end in a cornice bracket. The cornice is made of red brick with a multiple arch detail and is capped by a buff brick top with brackets. The second-storey facade has two medallions in iron just above the storefront cornice.

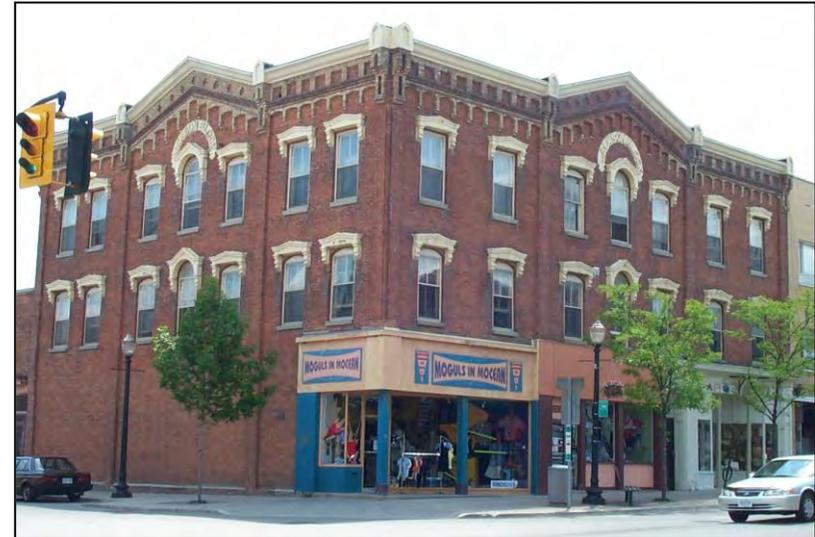
148-154 Broadway

148 - 154 Broadway, Jackson Block
Category A ☆☆☆

Date of construction: 1875
Architectural style: Italianate
Original owner: Thomas Jackson
Original use: Commercial
Present use: Commercial

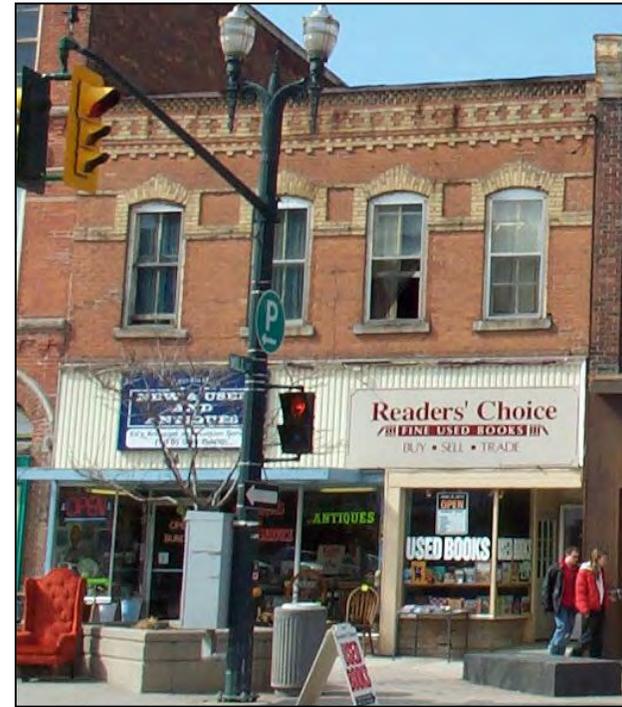
149-151 Broadway

The building is Italianate in design characterized by red brick with buff brick detailing. The upper floor has raised banding in buff brick from running window-to-window; three-course banding level with the bottom of the voussoirs and single-course banding at the shoulder of the voussoirs. The voussoirs are soldiered in buff brick, raised above the field, and peaked. There are no keystones. There are no pilasters. An elaborate cornice of buff and red brick tops the structure.

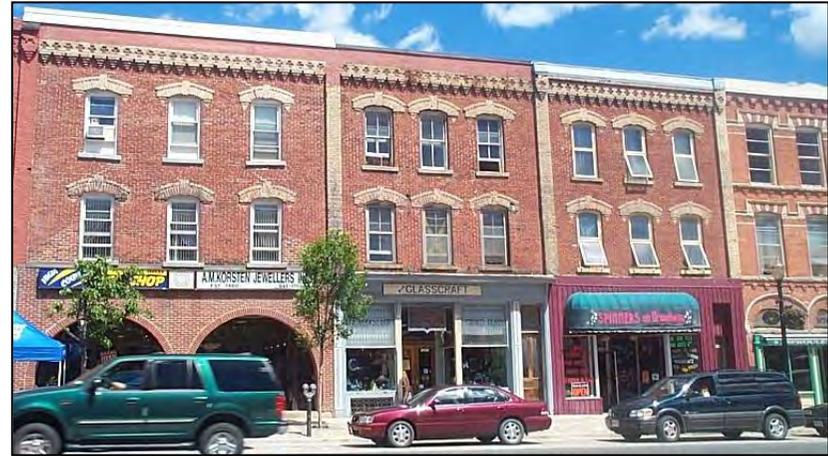
155, 159, 163-165 Broadway

This block is of Italianate design. The building is clad in red brick with buff brick detailing. The voussoirs are soldiered in buff brick with a raised buff brick edge and have keystones. Pilasters of buff brick divide the block into three units and also bookend the block. An elaborate cornice of red and buff brick tops the structure and is in good condition over 155 but has been partially removed over 159 and 163-165 Broadway.

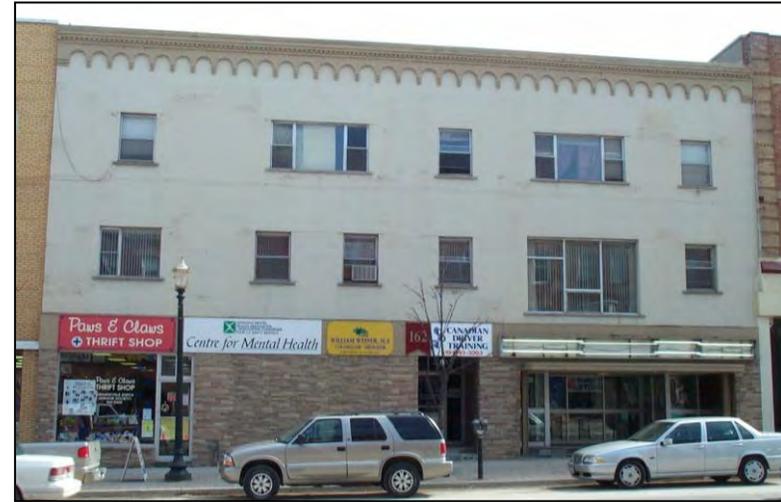
162 Broadway

162 Broadway, Chappel Building
Category C ☆

Date of construction:	1873
Architectural style:	Italianate
Original owner:	N/A
Original use:	Hotel
Present use:	Commercial/Residential

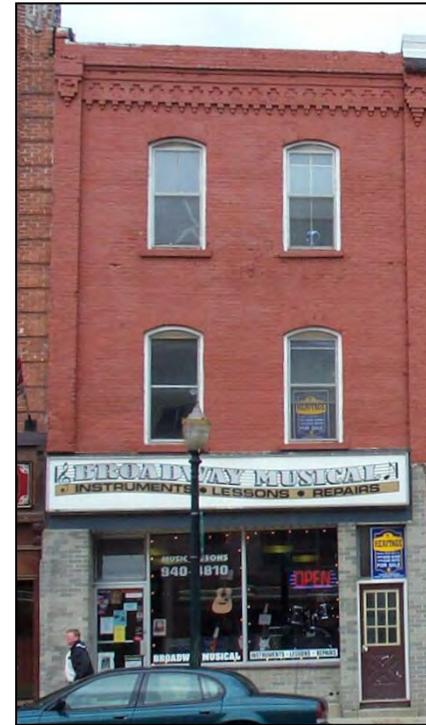
167-169 Broadway

This building is of Italianate design and is characterized by a red brick field which has been painted over. The pilaster on the west side of the building echoes the pilaster on the east which belongs to the commercial block to the east. The cornice is similar in detail to the cornice of the block to the east but on a smaller scale. The windows are topped by simple brick soldiering that also has been painted as have the stone sills. There are no keystones.

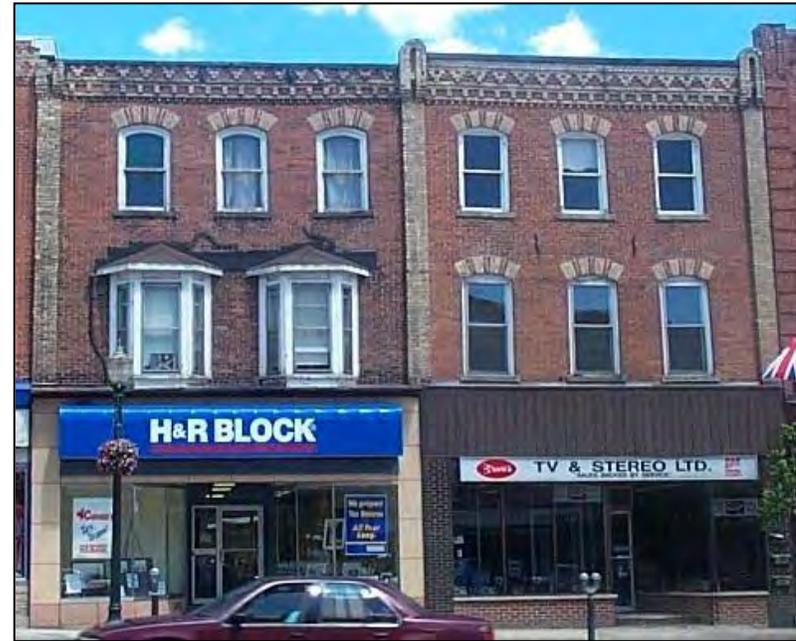
177, 181-183 Broadway

177 Broadway was constructed circa 1876 by T.C. McMurray as a jewellery store. Shortly thereafter, upon McMurray’s death, his widow married Thomas McAdam and they opened the Maple Leaf Grocery Store in this location. The upper floors were home to the Mechanic’s Library, the precursor to the Public Library. By 1921, the Banner newspaper was printing in the easterly half of the lower portion of this building with their offices and the Banner Book and Stationery store in the westerly half.

181-183 Broadway was constructed circa 1878 by George Campbell. Dr. Campbell set up his medical practice in the upper floors of this building from 1906 to 1972. The lower level was home to Menary’s Pool Room from approximately 1919 to 1945 and Chainway’s Department Store from approximately 1945 to 1970.

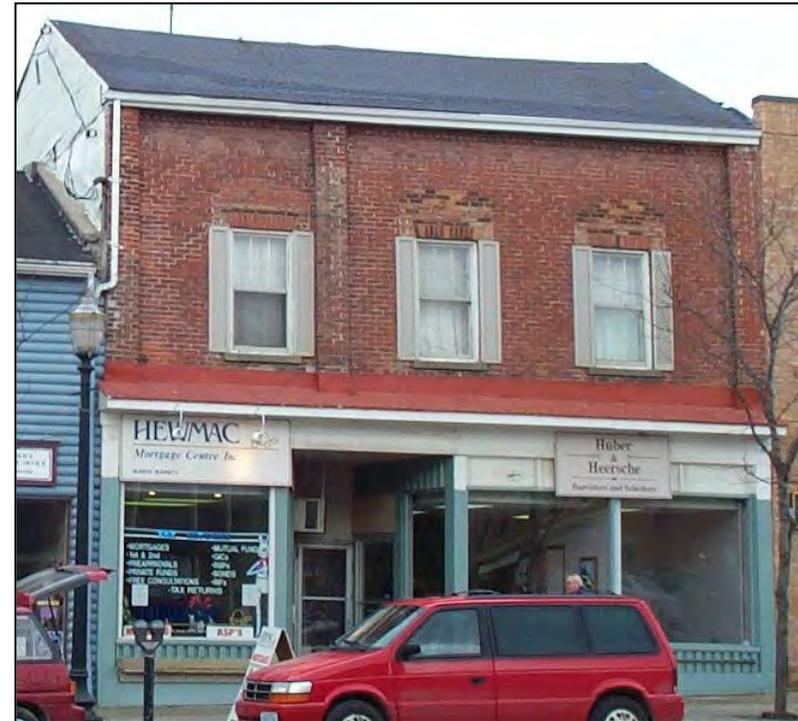
180-184 Broadway

This two-storey building was built as an Italianate block but has been reworked with a more Georgian roof shape. It is covered in red brick. Some evidence that this may have been an Italianate building include brick pilasters, original arch-topped window openings and a small portion of a brick cornice at the roof line.

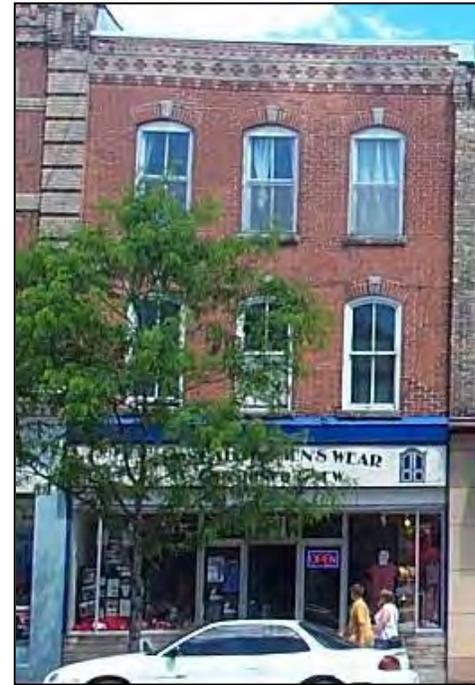
185 Broadway

This Italianate building is characterized by a red brick field and buff brick detailing on the elaborate cornice. The window openings are soldiered in red brick with stone keystones and sills. It appears that this building was built as a single unit infill between two existing blocks as the pilasters on either side of the facade are different belonging to the blocks to the east and west.

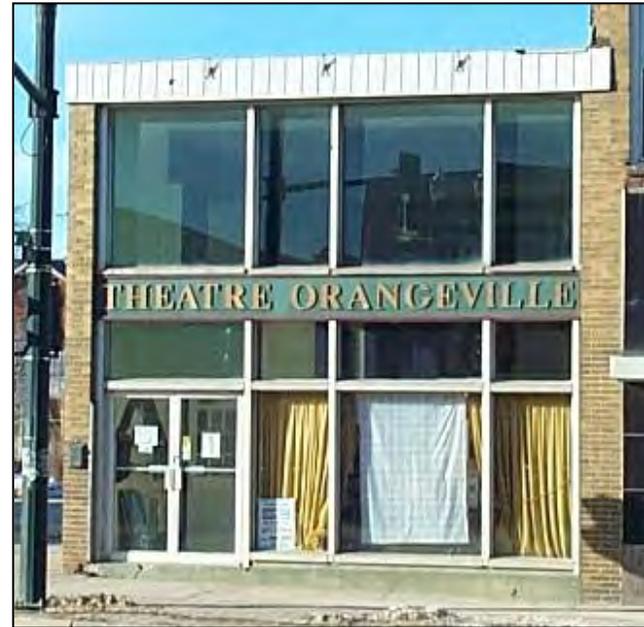
199 Broadway
Category C 🌟

Date of construction: c.1950
Architectural style: Modern
Original owner: Bank of Toronto
Original use: Commercial
Present use: Commercial

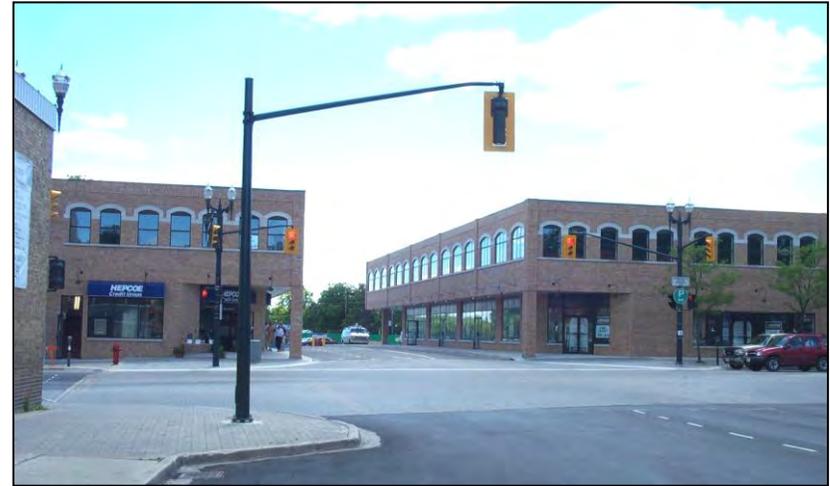
190 - 210 Broadway
Category B ☆☆☆

Date of construction: 2000
Architectural style: Modern
Original owner: N/A
Original use: Commercial
Present use: Commercial

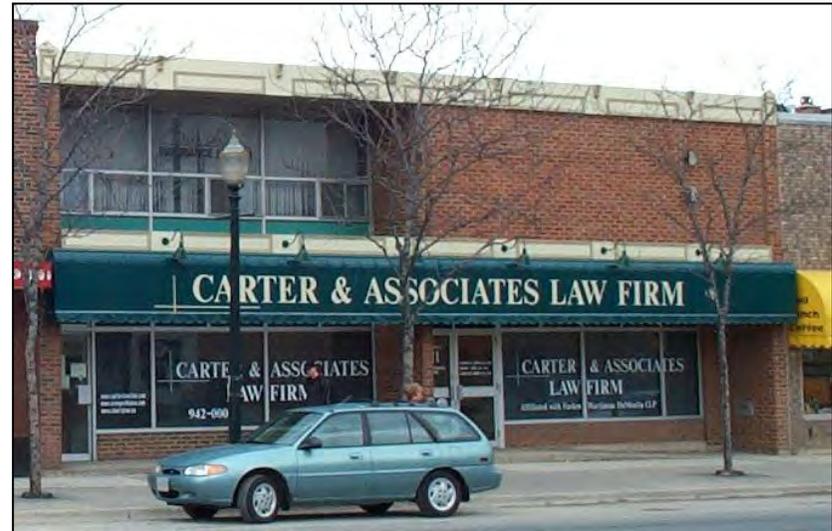
211 Broadway
Category C ✪

Date of construction: 1958
Architectural style: Modern
Original owner: Bank of Nova Scotia
Original use: Commercial (bank)
Present use: Commercial (offices)

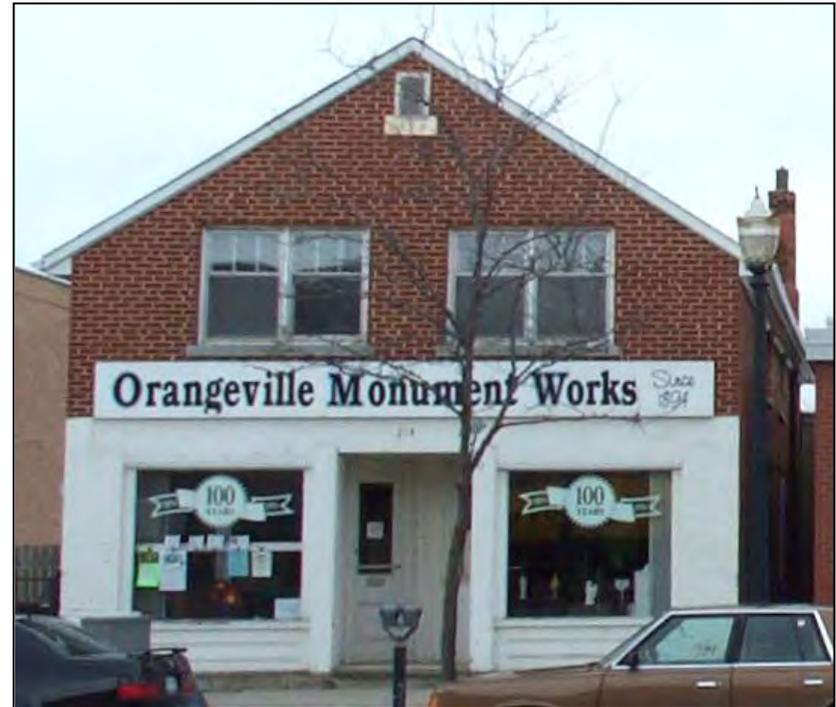
214 Broadway

This one-and-a-half-storey building has been significantly changed from its original design. Early photographs indicate that the front gable was covered by a large square parapet and windows in a “frontier” style. These were subsequently removed and new brick work now fills the front gable. The upper storey windows and openings date to the time of the removal of the parapet. The remainder of the building is clad in the original red brick.

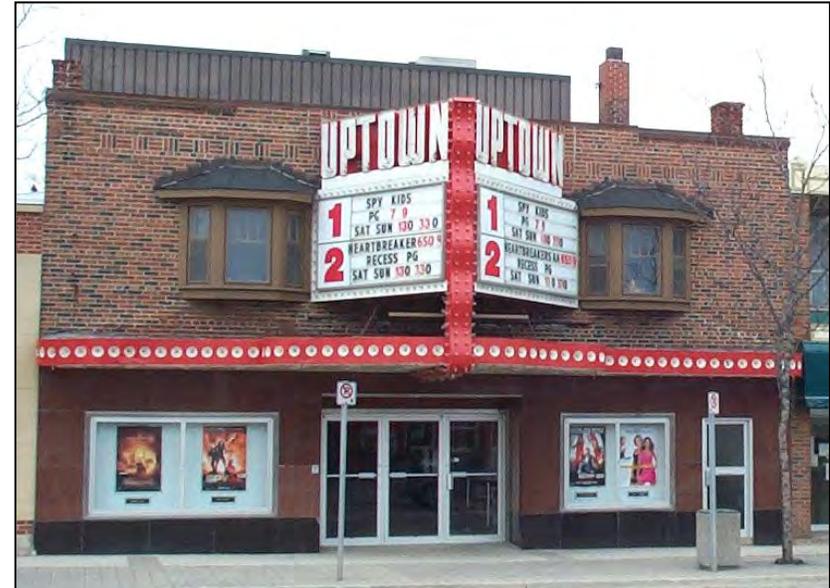
219 Broadway

This two-storey building was constructed during the Art Deco movement and has some simple details reminiscent of the time. The upper floor is clad in multi-coloured brick with low chimneys flanking the façade. There are no pilasters. A basket weave brick band runs across the façade above the second-storey windows. A typical mid-20th century movie marquee is mounted between the windows on the second storey projecting out from the façade.
