DOWNTOWN ORANGEVILLE HERITAGE CONSERVATION DISTRICT STUDY

*PREPARED BY:
TOWN OF ORANGEVILLE PLANNING DEPARTMENT
HERITAGE ORANGEVILLE*

MARCH, 2002

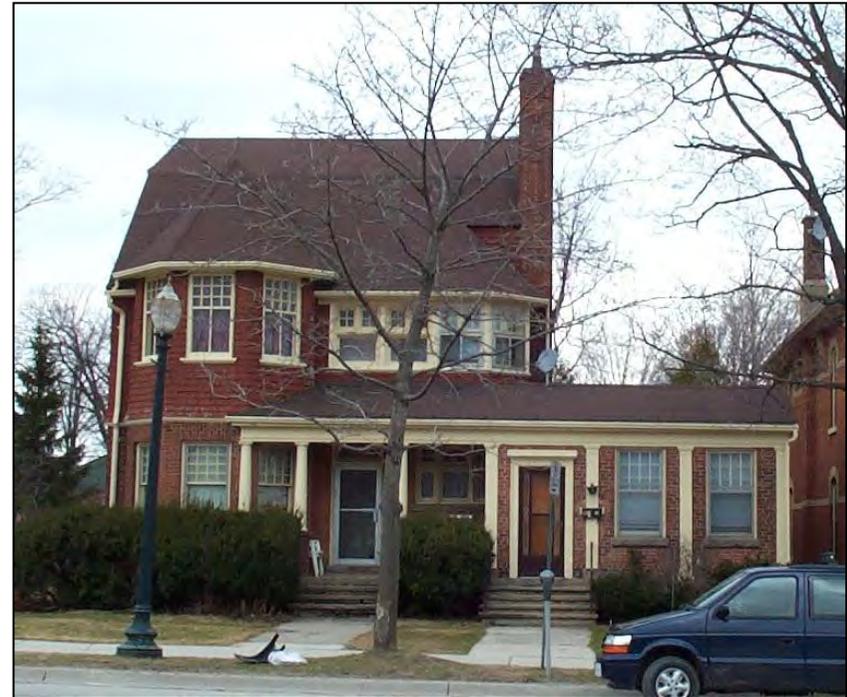
239 Broadway
Category N/A

Date of construction: c.1890
Architectural style: Queen Anne
Original owner: J.W. Acken
Original use: Residential
Present use: Residential

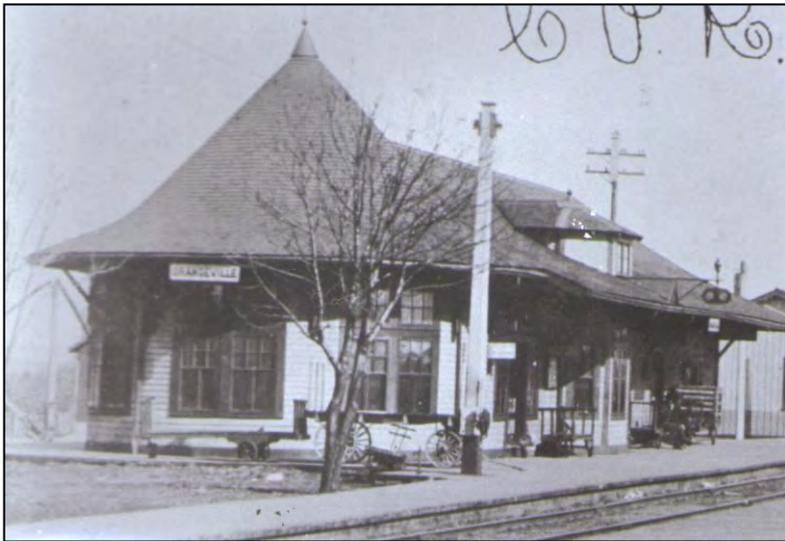
Old Train Station, c.1910

This building is one of three stations CPR built in this style. The others are in Parry Sound, Ontario and Ste. Agathe, Québec. The design is known as “stick and shingle”.
