December 5, 2019
WE 13016

**RE: Orangeville Highlands Phase 2 – Middle Monora Creek
Response to CVC Comments**

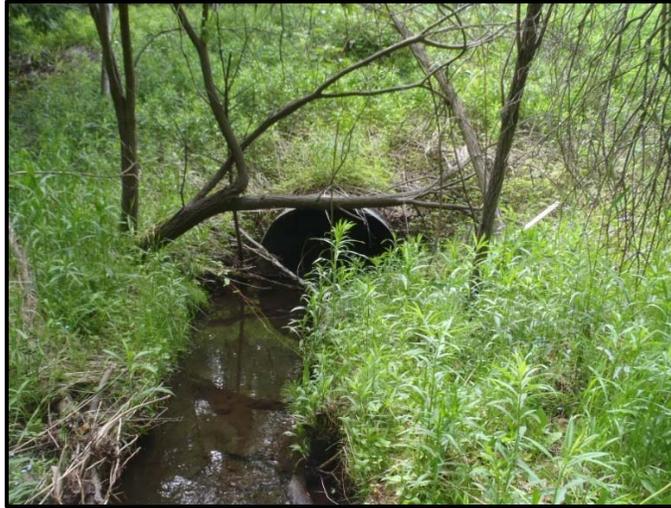
Photo 1: Upstream Side of Crossing

The comment to replace the culvert was provided as a recommendation based on the need for ongoing maintenance of the pedestrian crossing and by the fact that this crossing creates a backwater zone and impedes fluvial processes. However, the current structure has been in use since the construction of the Mall and surrounding property, which occurred in 1981, and the structure has not been noticeably affected by any subsequent flooding since that time.

Further background and details regarding the crossing are that the culvert is located between River Station 1.12 and 1.13 in the HEC-RAS model and is overtopped from the 10-year up to the Regional event. The culvert is a pipe arch CSP covered by a large earthen embankment that is used for pedestrian access across the creek. The pedestrian walkway receives grass cutting maintenance during the summer season. The existing conditions floodline for the culvert and embankment show a large backwater is created at this point, however it is noted that there is no increase in flood elevations upstream of the crossing in the post-development model (see **Photographs 1 and 2** for site details).

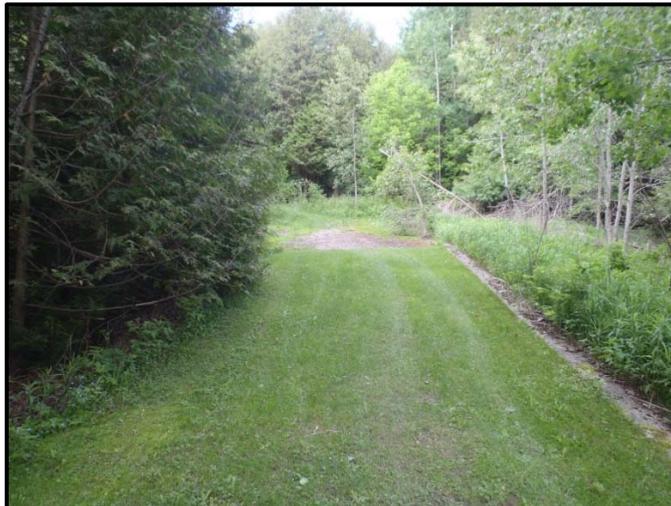
Photo 2: Pedestrian Path Over Crossing
